INDIANA DEPARTMENT OF ENVIRONMENTAL MANAGEMENT

Ex-Situ Treatment of Dense Non-Aqueous Phase Liquids Using Calcium Oxide (Quick Lime)

Guidance Created: February 10, 2009

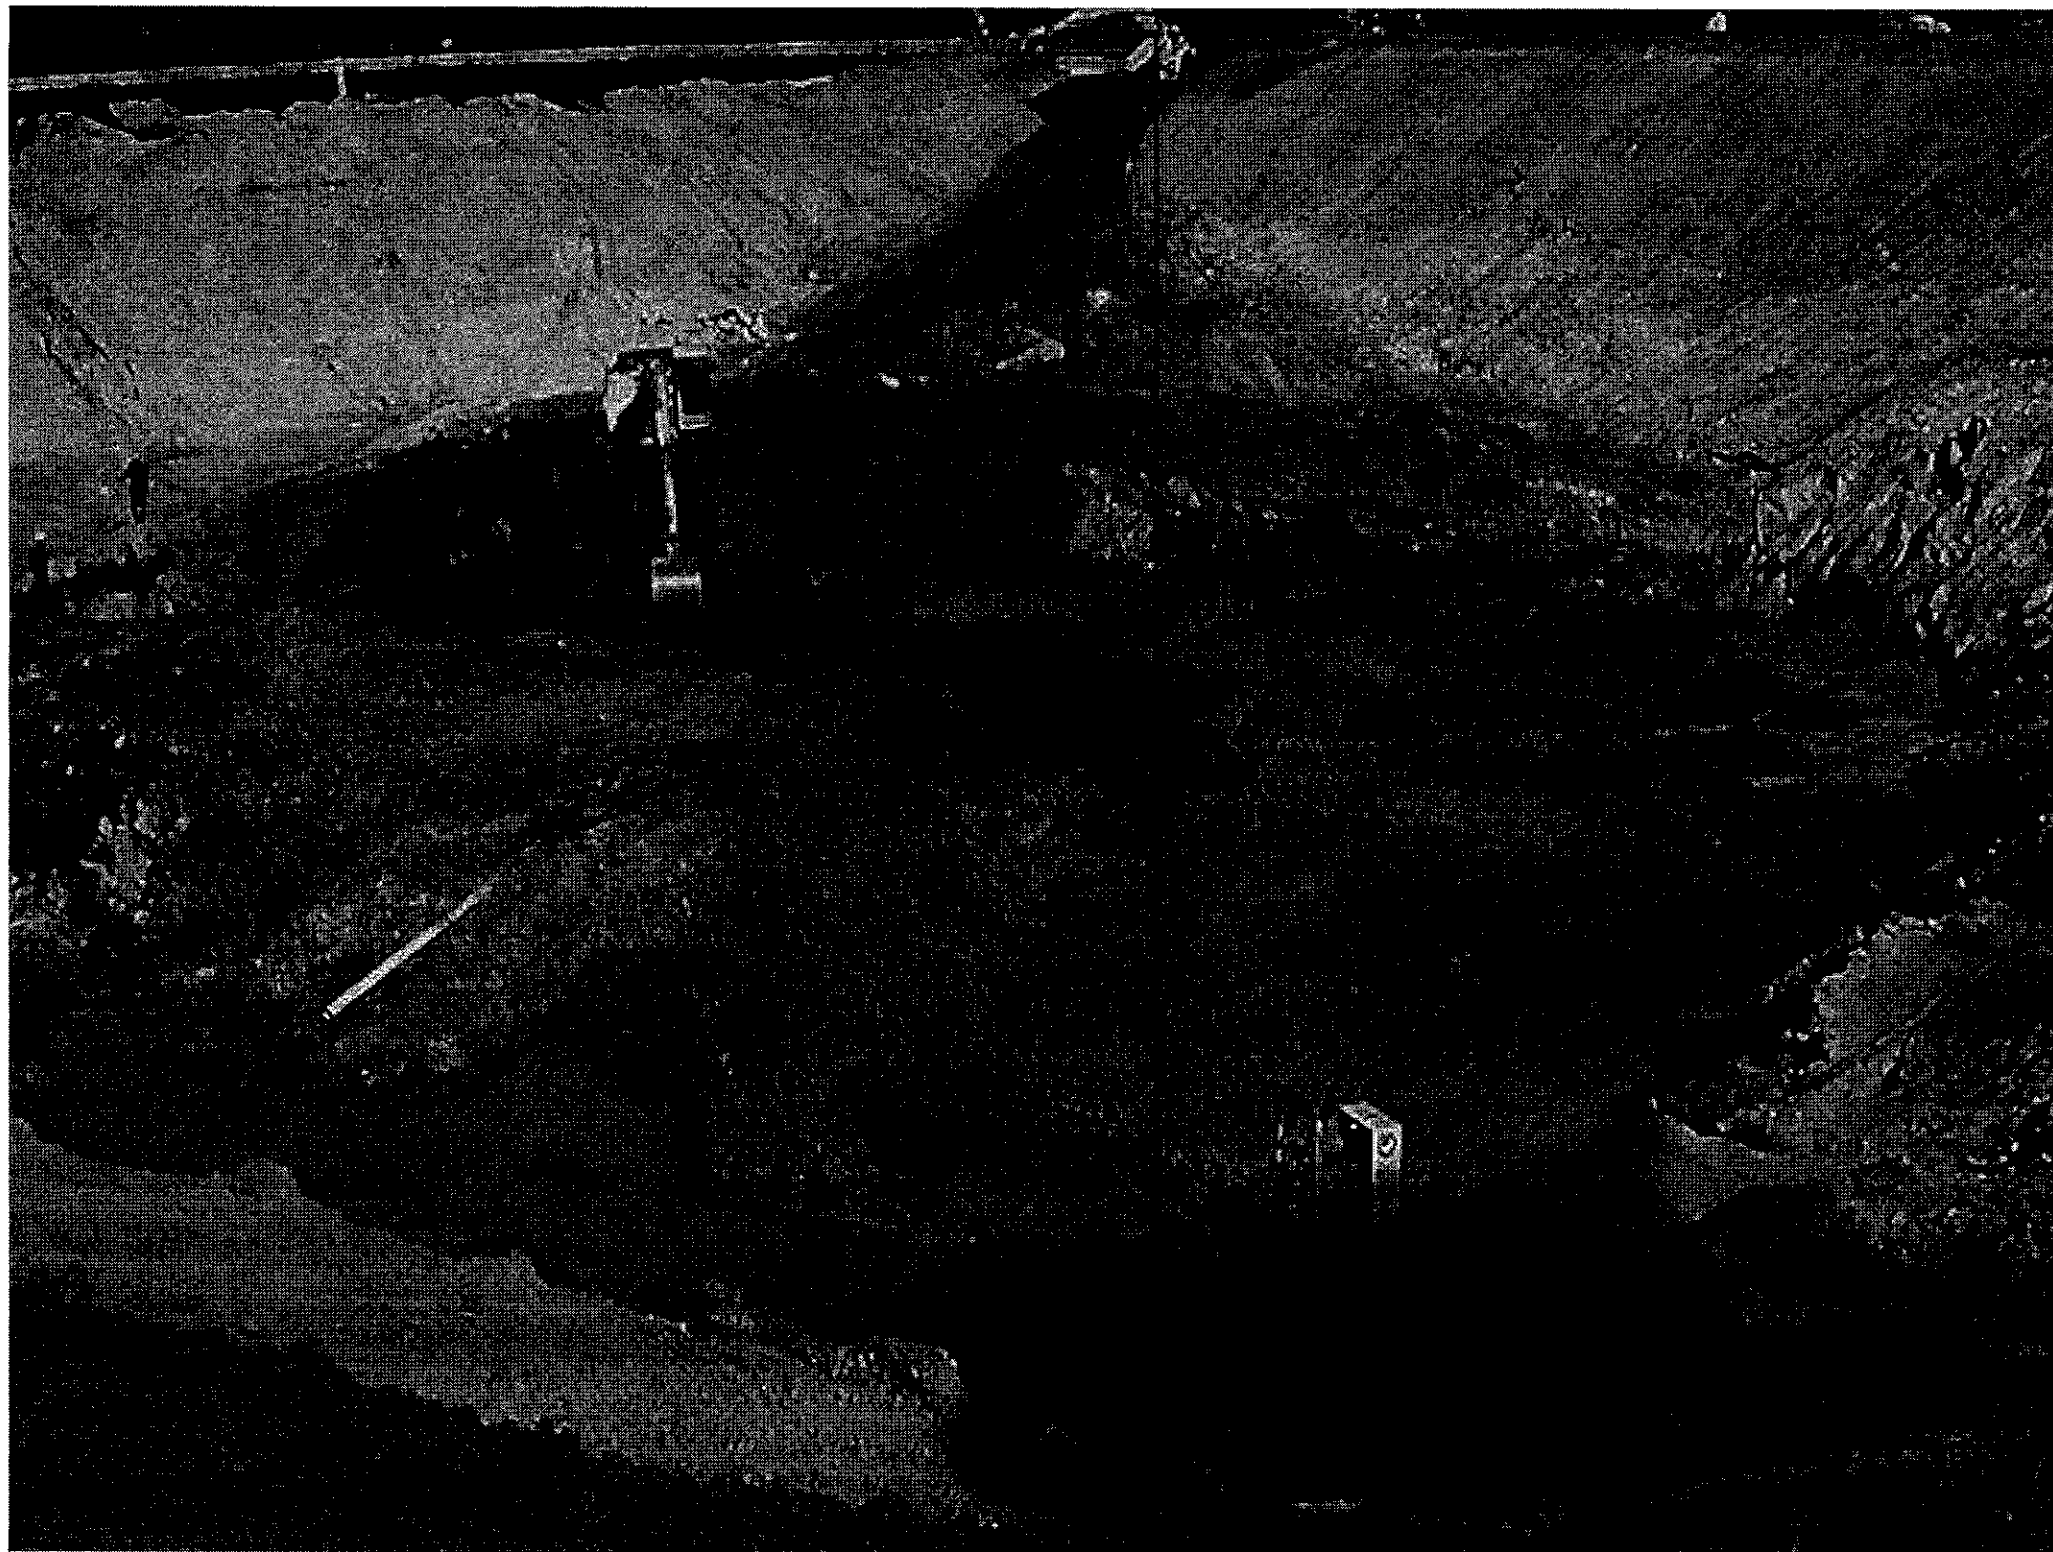
Lined Pond
Used for Soil
Treatment

Excavation of
Contamination
Source Areas

Soil
Processing
Area
